RE: Site Inspection, Cotter Corporation, Papoose Mine and Exploration, M/037/084 and E/037/094, San Juan County, Utah

Date of Inspection: August 15, 2002
Time of Inspection: 1:45-2:15 p.m.
Conditions: Mostly sunny, 80's
Participants: Doug Jensen and Paul Baker, DOGM; some employees were on site, but they did not accompany us

**Photographs
S/037/084 and E/037/094
Papoose Mine and Exploration**

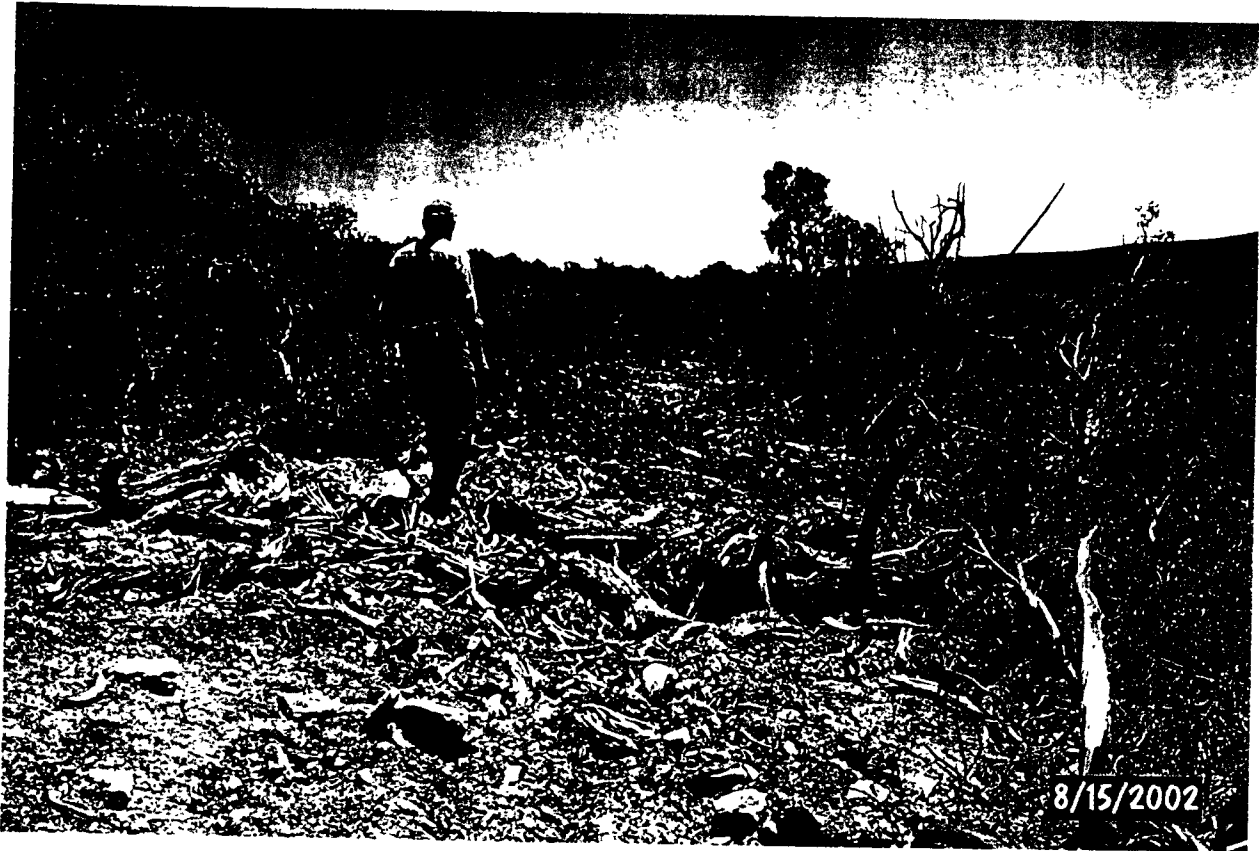
Photo 1. Papoose exploration reclaimed area.

The operator has roughened the exploration area and spread brush over the surface (Photo 1); however, there was very little vegetation in the reclaimed area.

The operator did a good job preparing the surface of the exploration area, and I expect the area will eventually have good vegetation cover. Eastern Utah is in a severe drought, and this is probably the reason there is so little growing. There could still be some viable seed from last year's seeding, but the operator should not rely on something so uncertain. The exploration area needs to be reseeded this fall, and the seed should be raked into the soil.
